# EFFECTS OF HYDROELECTRIC DAM CONSTRUCTION ON LAND USE LAND COVER CHANGES IN BUI NATIONAL PARK, GHANA

Godfred Bempah <sup>a\*</sup> - Prince Boama <sup>b</sup>

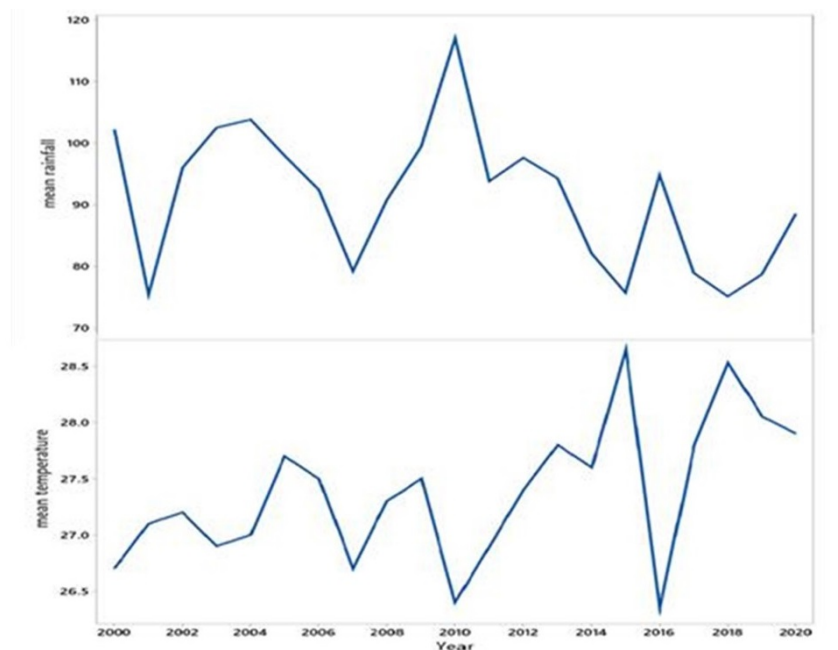
The highest decade mean temperature ( $27.69 \pm 0.219$  °C) was recorded for 2011–2020 compared to the decade 2000–2010 with  $27.16 \pm 0.108$  °C. The highest decade mean rainfall ( $93.96 \pm 3.094$  mm) was recorded for 2000–2010 compared to 2011–2020 with  $85.954 \pm 2.77$  mm. Results of Mann Whitney U test showed that the differences in the two decades were significant for mean rainfall ( $U = 24$ ,  $\rho < 0.05$ ) and mean temperatures ( $U = 22.5$ ,  $\rho < 0.05$ ).

Figure 2 - Trends of changes of mean rainfall (mm) and mean temperature (°C) from 2000 – 2020 at BNP

There was a negative correlation ( $r = -0.609$ , Figure 2), and estimated value from the series' cross correlation function (CCF) was significant ( $p = 0.003$ ) between the mean rainfall time series and the mean temperature time series for the study period.

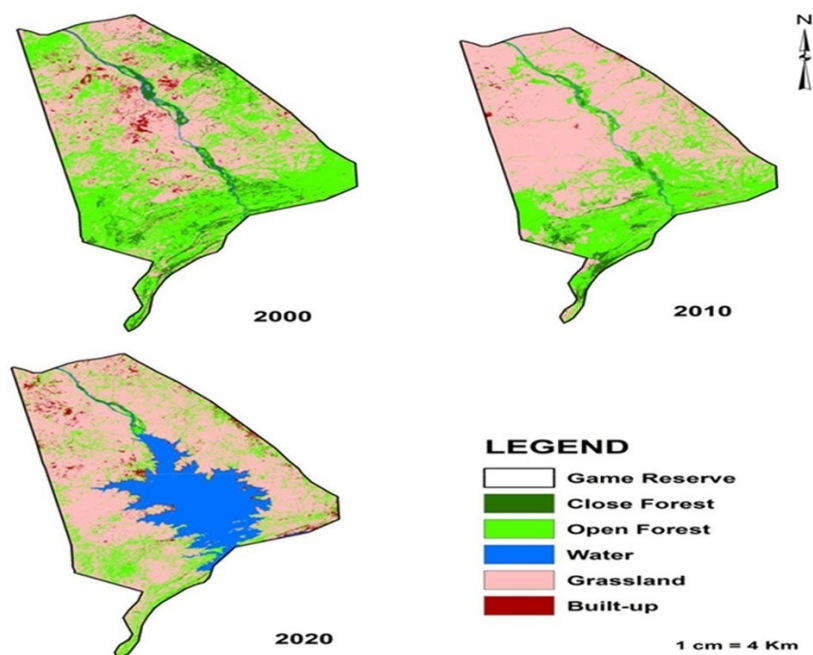
In all, five land cover types were identified, namely; built-up, close forest, grassland, open forest, and water body. A set of three different land cover maps covering the study area for the years 2000, 2010 and 2020 is shown in Figure 3.

Figure 3 - Land cover maps of the Bui National Park for the years 2000, 2010 and 2020.

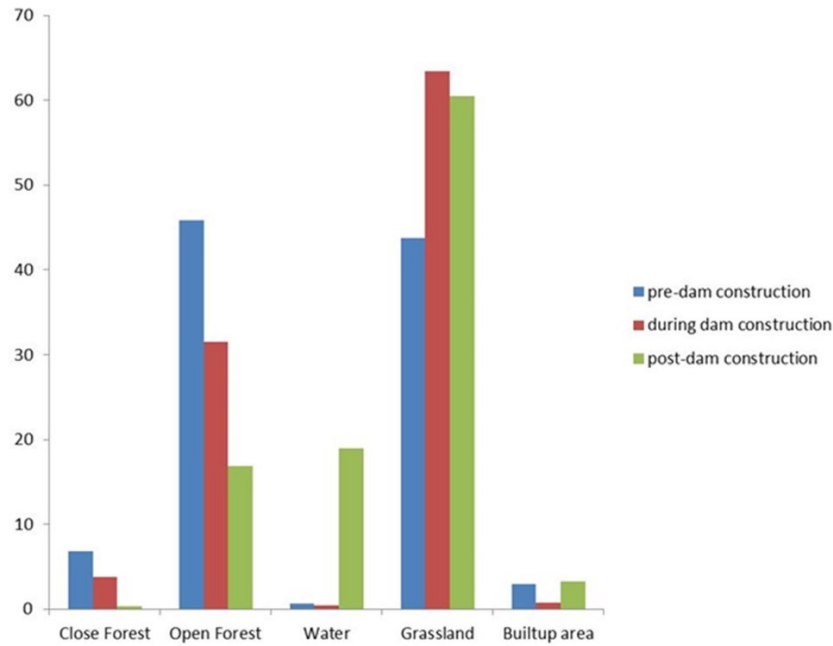
Kruskal Wallis test indicated significant difference among the various landcover classes ( $H = 9.33$ ,  $p < 0.05$ ) and Tukey's post hoc analysis revealed a significant difference between five out of the 10 pairs of the land cover classes. Before the dam construction, open forest occupied the largest portion of the total land area with 45.87 % (Figure 4). However, this changed during the post-dam construction, with grassland (60.54 %) occupying the largest percentage cover, followed by water body with 19.01 %.

Figure 4 - Percentage of area covered by each Land cover types; pre, during and post dam construction.

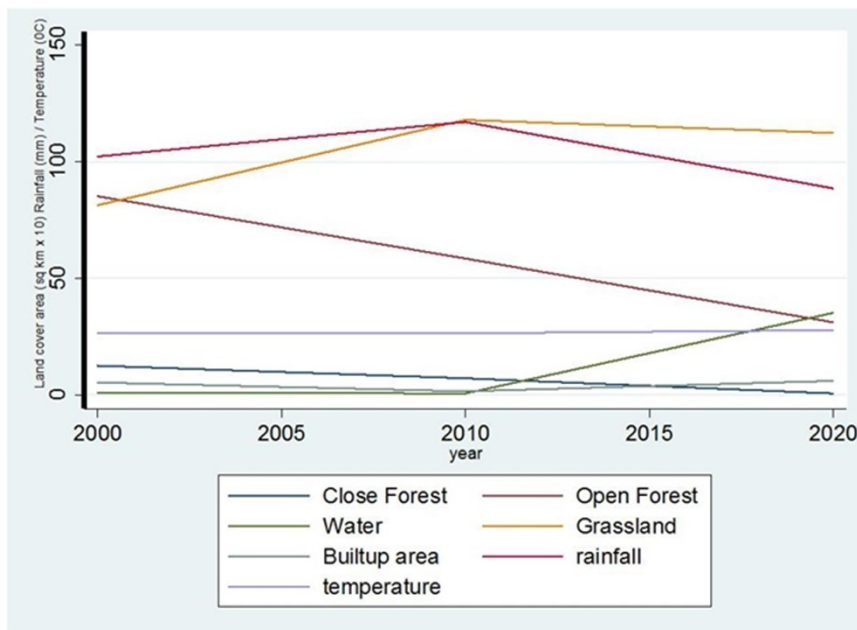
Land cover changes and climatic variables seem to follow a similar trend over the period after the dam construction (Figure 5). For example, a decrease in the amount of rainfall corresponded with a decrease in close forest and open forest. During the same period, water body, grassland and builtup area increased with marginal increase in temperature. Increase in water body results from the reservoir

created by the dam and grassland and builtup area is caused by forest degradation corresponding with temperature increase

Figure 5 - Land cover, rainfall and temperature changes with the construction of the dam
