# CHARACTERIZATION AND ANALYSIS OF GULLY EROSION IN SOUTHERN BRAZIL WITH THE ASSISTANCE OF UNMANNED AERIAL VEHICLE

The ability to understand the erosive mechanisms of a gully is of great importance for determine its dynamics and the best forms of intervention. Thus, with the assistance of high-resolution data obtained with UAV, this work seeks to characterize and analyse the erosive mechanisms that act in a gully in south Brazil. For this, a survey was carried out using a multirotor UAV, with a flight height of 150m, and an overlaid area of 67ha. The data obtained were processed using the SfM-CMVS (Structure from Motion - Clustering Multi-View Stereo) workflow, generating a Digital Terrain Model with a spatial resolution of 12,6 cm/pixel. However, mass movements proved to be the main lateral and vertical advancement agent of the gully, predominating in the upper portions of the gully. In the lower third of the gully there was a predominance of mass movements and lowering areas related to the contact of sandy rock lenses with more clayey lenses. The products generated in this work provide a database that has the potential to assist in work to be developed, serving as a basis for th

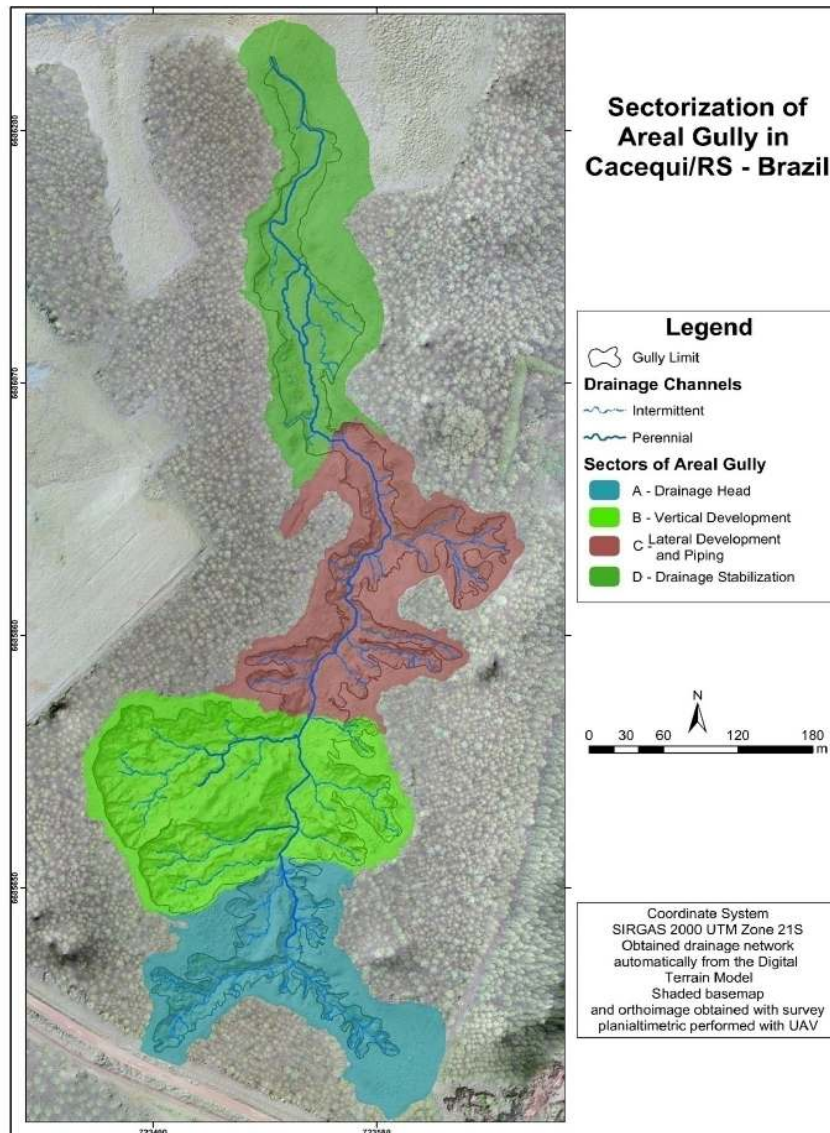
Figure 2 - Sectors of Areal Gully in Southern Brazil.

Due to the large extension of the Areal Gully and the detailed study carried out, four different sectors of the gully were defined considering the different mechanisms of the gully (Figure 2). The sectors were defined as: A - Drainage head; B - Vertical Development; C - Lateral Development and Piping; and D - Drainage stabilization.

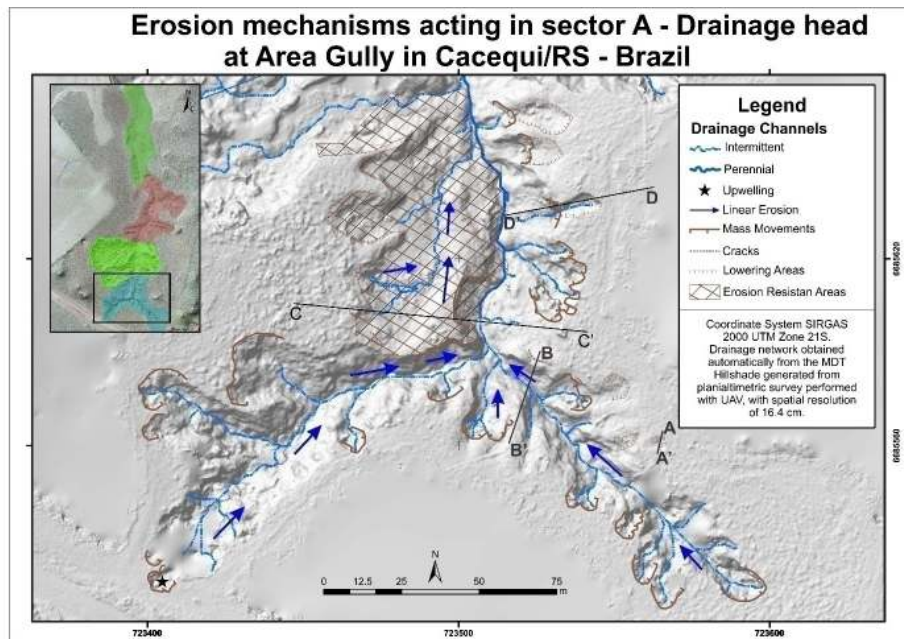
Figure 3 - Map of erosive mechanisms operating in sector A of Areal Gully.

The headwater drainage sector (Sector A) is located in the upstream portion of the gully, with a predominance of mass movements in the areas of advance and linear erosion in the channel at the base of the gully. An area of resistance to erosion on the west margin of the gully is also highlighted (Figure 3).

This sector has 23 traces of mass movements, 7 cracks and 9 lowering areas. The sector exhibits two main ramifications, predominance of mass movements as a form of lateral advancement, and in the ramification on the right margin of the gully, as well as the occurrence of lowering areas.

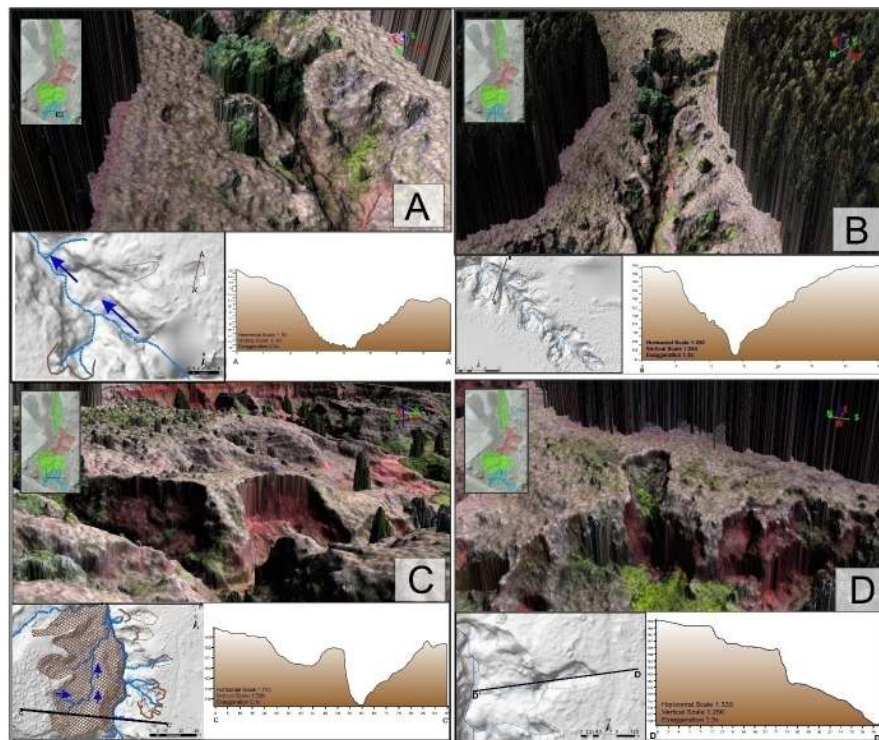
Figure 4 - Schematic representation of the mechanisms acting in sector A (A - Lowering Area; B - Linear Erosion; C - Erosion-resistant portion; D - Lowering followed by mass movement).

The intersection of the two ramifications of the sector includes an area resistant to erosion on the left margin. This area has smoother slopes, a lowering area, and a mass movement area close to the main gully channel. Furthermore, in the ramification on the east margin of the sector, the lowering with a

semicircular shape and disconnected from the gully drainage network can be seen in Figure 4A, represented by the profile A-A'.

Linear erosion occurs intermittently in this sector, concentrating the flow in the lower areas and carrying the eroded material downstream, represented in the cross section of Figure 4B. Linear erosion in this sector occurs with the formation of V-shaped valleys, with abrupt walls over 10 meters high, following preferential guidance, which suggests structural control in these areas. The vertical walls of this portion of the gully also facilitate mass movements, evidenced by the occurrence of cracks in the top of the gully.

The erosion-resistant area (Figure 4C) displays continuity of relief and vegetation in relation to the surrounding area with lower slopes. This feature is more resistant to erosion and has some lower areas in the center, forming converging concave portions, as observed in the topographic profile C-C'. These portions favor surface runoff and flow concentration, increasing both erosion and incision in the hillslope. Close to the main channel of the gully, mass movements with great intensity still form vertical walls over 10 meters high, based on the level of the gully groundwater. Also in sector A, mainly on the right margin of the main channel, areas of lowering followed by mass movement are common, as shown in the diagram in Figure 4D.

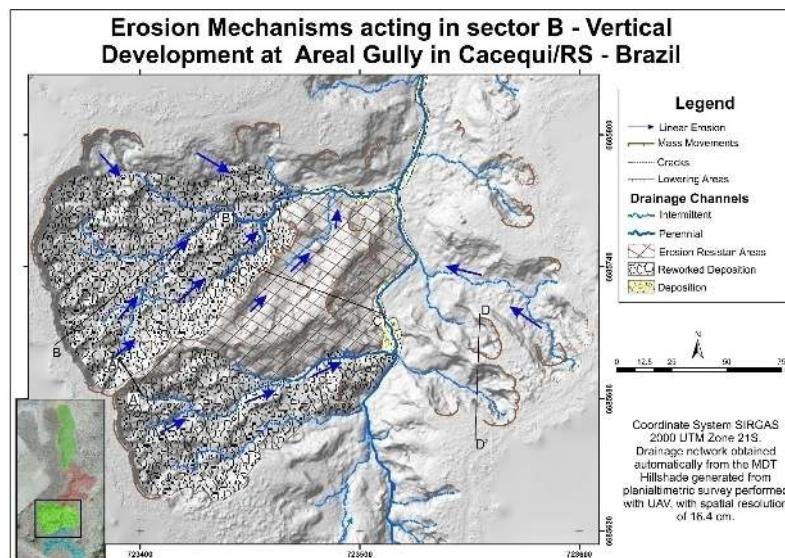
Figure 5 - Map of erosive mechanisms operating in sector B of Areal Gully.

Sector B of Areal Gully presents 31 features of mass movements, 3 cracks, and 4 downgrade areas. It is the part of the gully that has the largest eroded volume, with major occurrences of mass movements of great intensity. Due to the large eroded and deposited material at the base, the sector has a large area of reworked deposits. It also has material deposition areas and an area more resistant to erosion in the center of the sector (Figure 5).

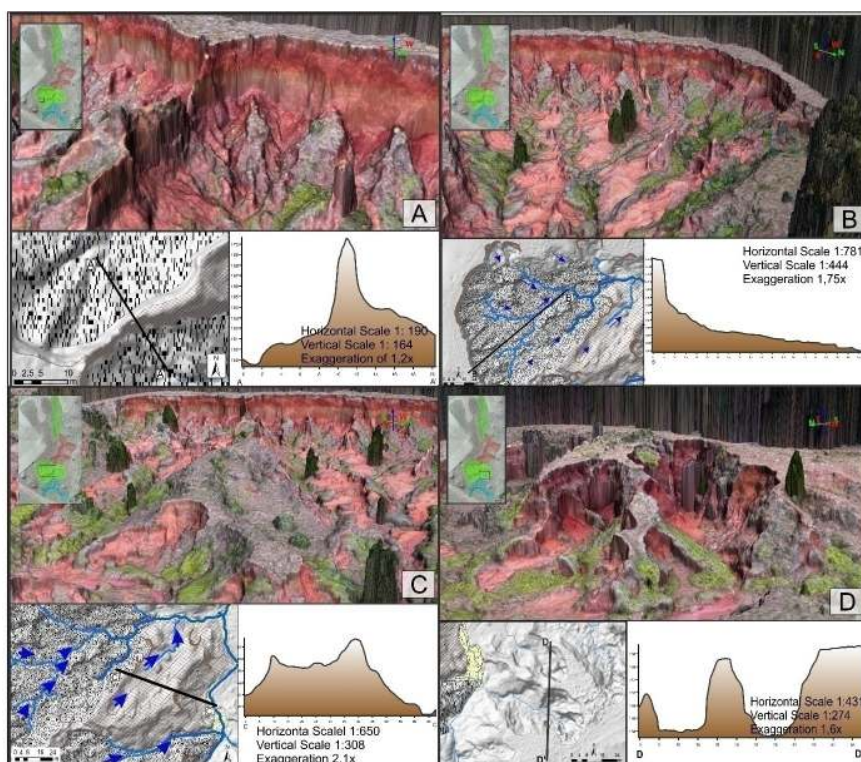
Figure 6 - Schematic representation of the mechanisms acting in sector B (A - Erosion resistant line; B - Vertical development area; C - Erosion resistant area; D - Area of occurrence of intense mass movements).

Despite the predominance of erosion mechanisms with vertical development in this sector, there is

the occurrence of erosion resistant lines, represented in the scheme of Figure 6A. Form between two large areas of vertical advance, they are over 9 meters high and about 2 meters wide. These features connect the central basement of the sector, which is more resistant to the gully's edge, showing the existence of a less erodible material in some portions of the gully.

The main feature of this sector is the vertical development of the gully, with a depth of approximately 25 meters, presenting abrupt very sloped walls, as shown in Figure 6B. These abrupt walls represent a great erosive advance, where the edge of the gully is marked by a sequence of semicircles demonstrating the occurrence of mass movements, resulting in a large volume of eroded material. As a result, at the base of the hillslope, it is possible to observe a large amount of sediments from past mass movements, forming a deposition area.

A portion more resistant to erosion occurs in the center of the gully (Figure 6C). This portion forms a bounce feature in relation to the surroundings due to differential erosion, where less intense processes occur, which is predominantly linear erosion in the central part of the feature, where a small downgrade occurs, forming a converging hillslope. The right margin of the sector has mass movements with great magnitude where the gully is most active, forming small ramifications with slopes of more than 12 meters, with abrupt walls and small intermittent drainage channels at the base, as shown in Figure 6D.

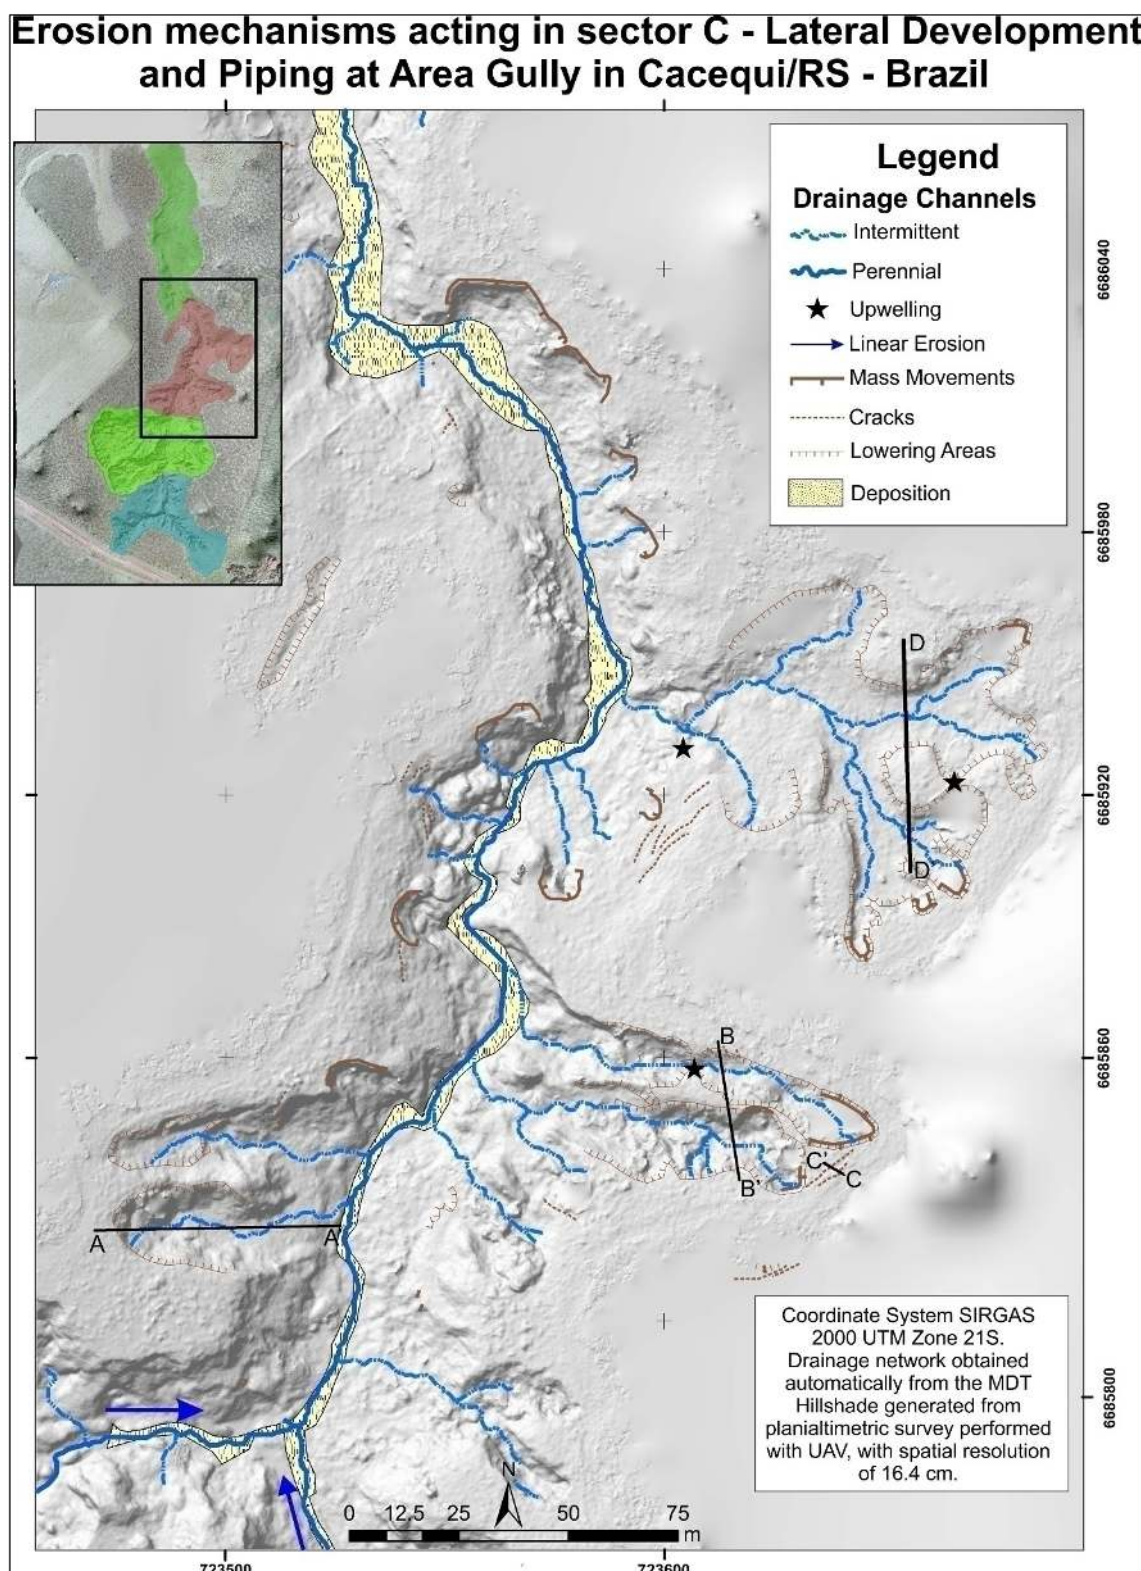
Figure 7 - Map of erosive mechanisms operating in sector C of Areal Gully.

Sector C of the gully, located in the lower third of the gully (Figure 7), has several ramifications and areas of lateral advance, with 19 areas of mass movements, 22 cracks, and 18 downgrade areas. The large number of downgrade areas in relation to the other sectors is an indication of greater action by the piping mechanism responsible for the removal of material on the subsurface and consequently forming

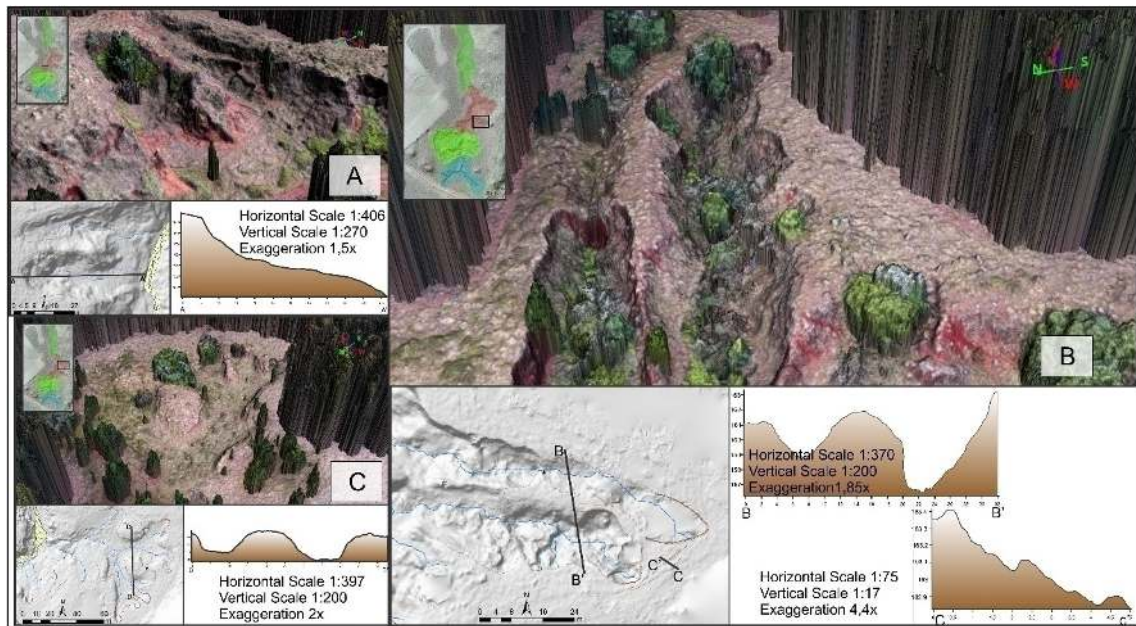
Figure 8 - Schematic representation of the mechanisms acting in sector C (A - Downgrade area; B - Parallel branches associated with the downgrade and crack formation areas; C - Downgrade area).

One of the most common erosive mechanisms in this gully sector is the downgrades (Figure 8A), where a large area with a semicircular edge undermines, forming a converging area, with a smoothed profile, without the occurrence of vertical walls, and the establishment of intermittent channels in the center.

The occurrence of these lowerings may be associated with the existence of more clayey rock lenses at the base, favoring underground erosion at these points. These lowering points form a converging feature that favors the surface runoff of water, concentrating moisture and making vegetation in these areas more common, as seen in Figure 8A.

The right margin of the sector contains two parallel and linear shaped ramifications (Figure 8B), which are between 3 and 7 meters deep. The two branches are divided by a small strip of land less than 10 meters wide (Profile B-B', Figure 8B), where water erosion processes and small mass movements occur, contributing to the retreat of this portion of land and a possible joining of the ramifications.

The activity of mass movements in this area is observed in the formation of cracks upstream from the feature, represented in the topographic profile C-C' of Figure 8B. In this portion of the gully sector, the occurrence of upwelling evidences the action of underground erosion.

Further downstream in the gully, ramifications of distinct characteristics are a greater widening of the feature and less depth, reaching about 3 meters in depth, as shown in the topographic profile D-D' of Figure 8C. The base of the gully in this portion has a flat bottom, possibly due to the presence of more clay lithology sheets close to the surface. The headland area also exhibits a small advance of the ramification through small mass movements.

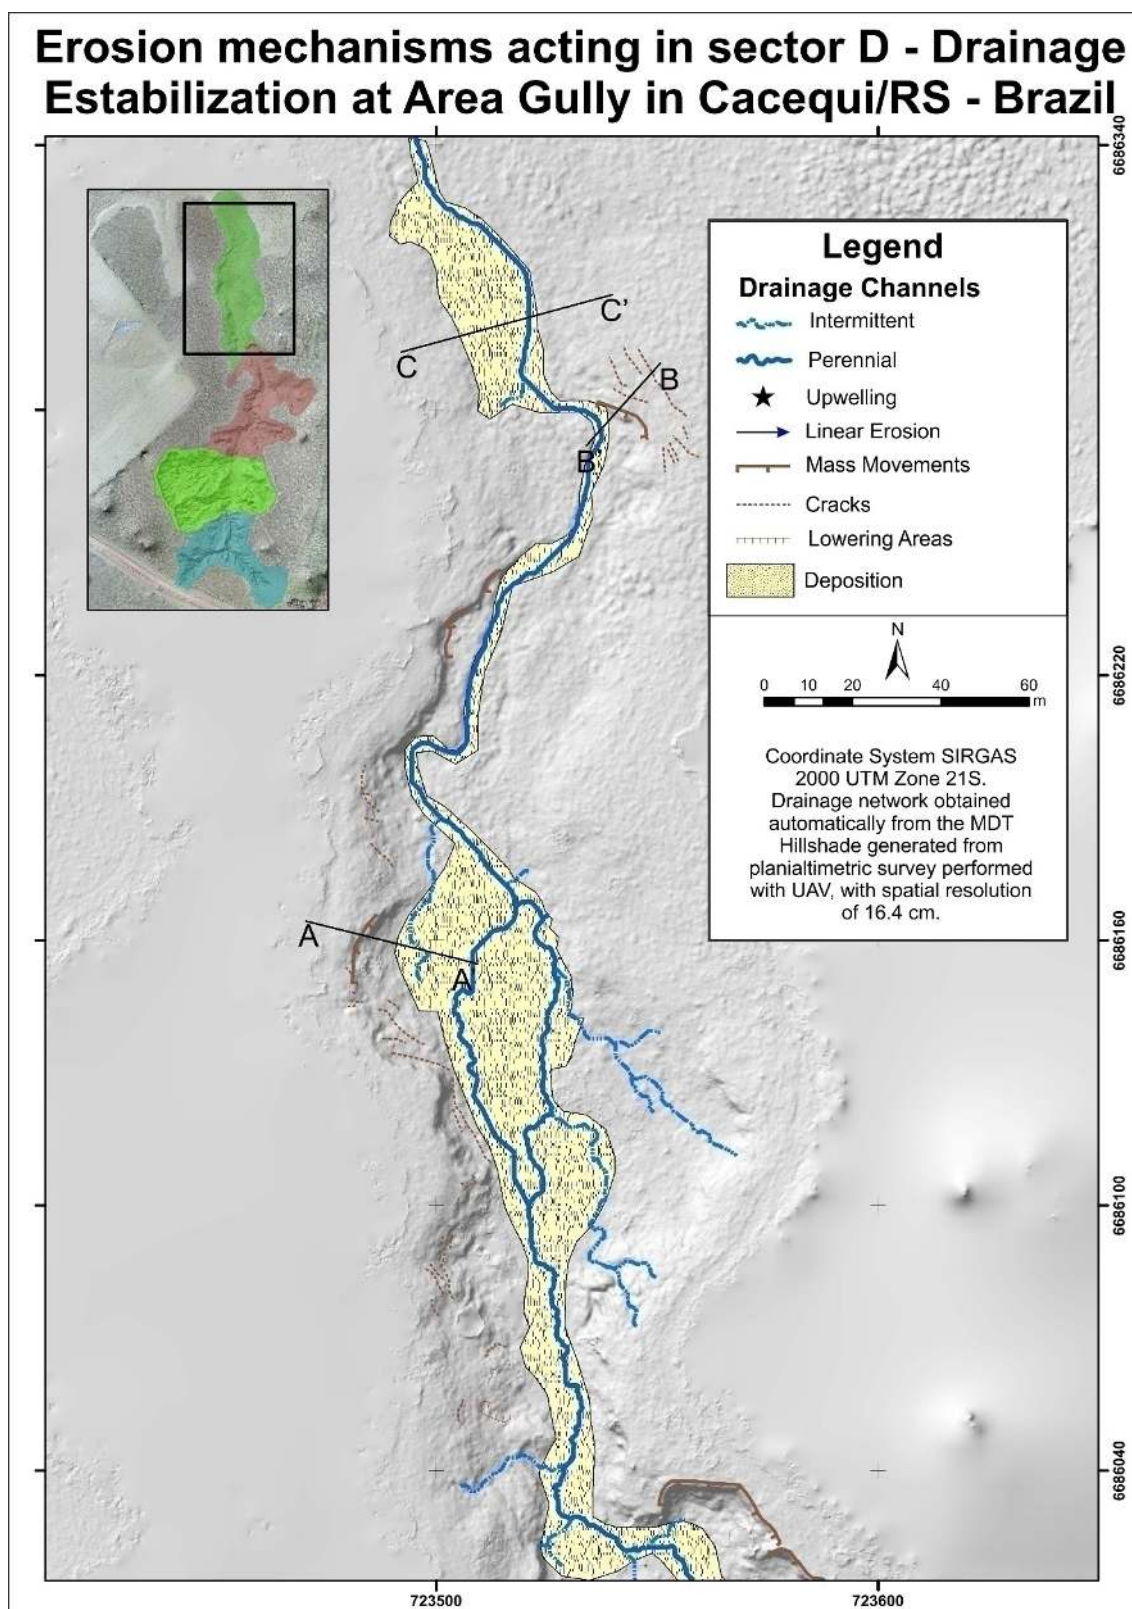
Figure 9 - Map of erosive mechanisms operating in sector D of Areal Gully.

Sector D is located in the most downstream portion of the gully (Figure 9), characterized by the stabilization of the gully, containing only five signs of mass movements, and one of lowering but with a greater occurrence of cracks, adding up to 33. In this sector, the main channel is already well established, with deposition areas close to the channel and the main mechanism is deposition; however, the side walls still exhibit erosion mechanisms.

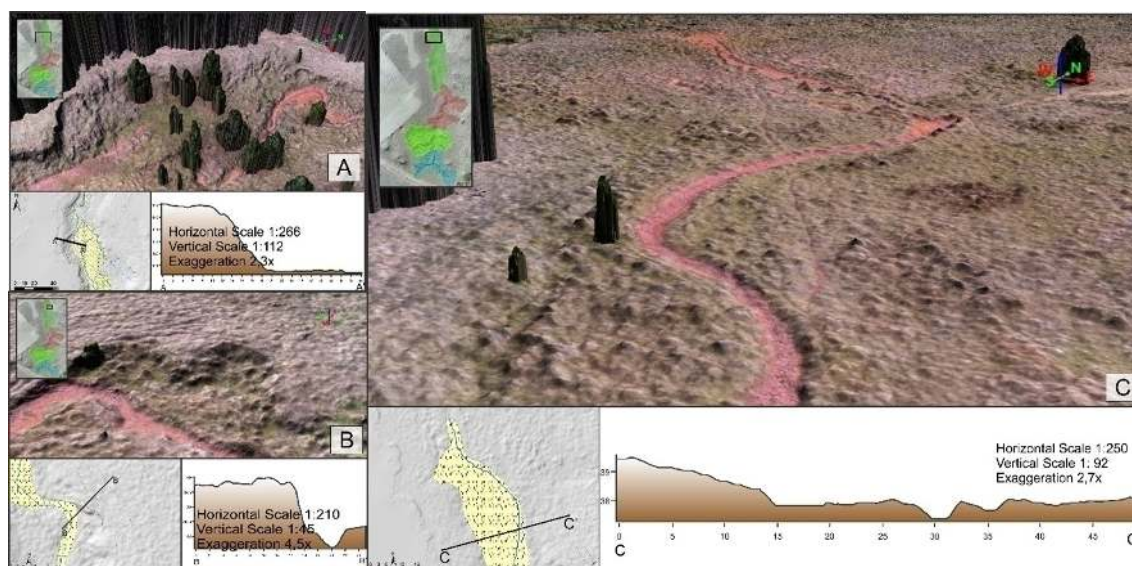
Figure 10 - Schematic representation of the erosive mechanisms acting in sector D (A - Mass movements; B- Small mass movements and associated cracks; C - Flat area).

Although the sector is characterized by the stabilization of the gully and is located in the lowest portion, it is still possible to observe the mass movement mechanism acting on the development of the gully. These mass movements occur close to the gully wall, near the main channel, about five meters high (Figure 10A), having at its base a large amount of deposited material resulting from upstream erosion. These are softer mass movements, due to their proximity to the base level, but they contribute to

Further downstream in the sector, small mass movements, approximately two meters high occur, as shown in the profile B-B' in Figure 10B. Along with these mass movements, there are also several cracks and small ridges in the relief, of a few tens of centimeters.

This sector as the lowest in Areal Gully is where the aggradation processes predominate, with the deposition of material and flattening of the relief, as can be seen in Figure 10C. In the final portion of the gully, a perennial drainage channel is established, surrounded by areas of deposition of material and flat areas, without the presence of abrupt walls, characterizing itself as a first order channel and thus being the end of the gullying area. Therefore, sector D of the gully presents smoother mass movements, less expression, and less eroded material, mainly due to its proximity to the base level. The deposition of fine material due to upstream erosion and stabilization of the drainage channel prevails in the sector, connecting with the river network of the hydrographic basin of the Areal do Limeira River.

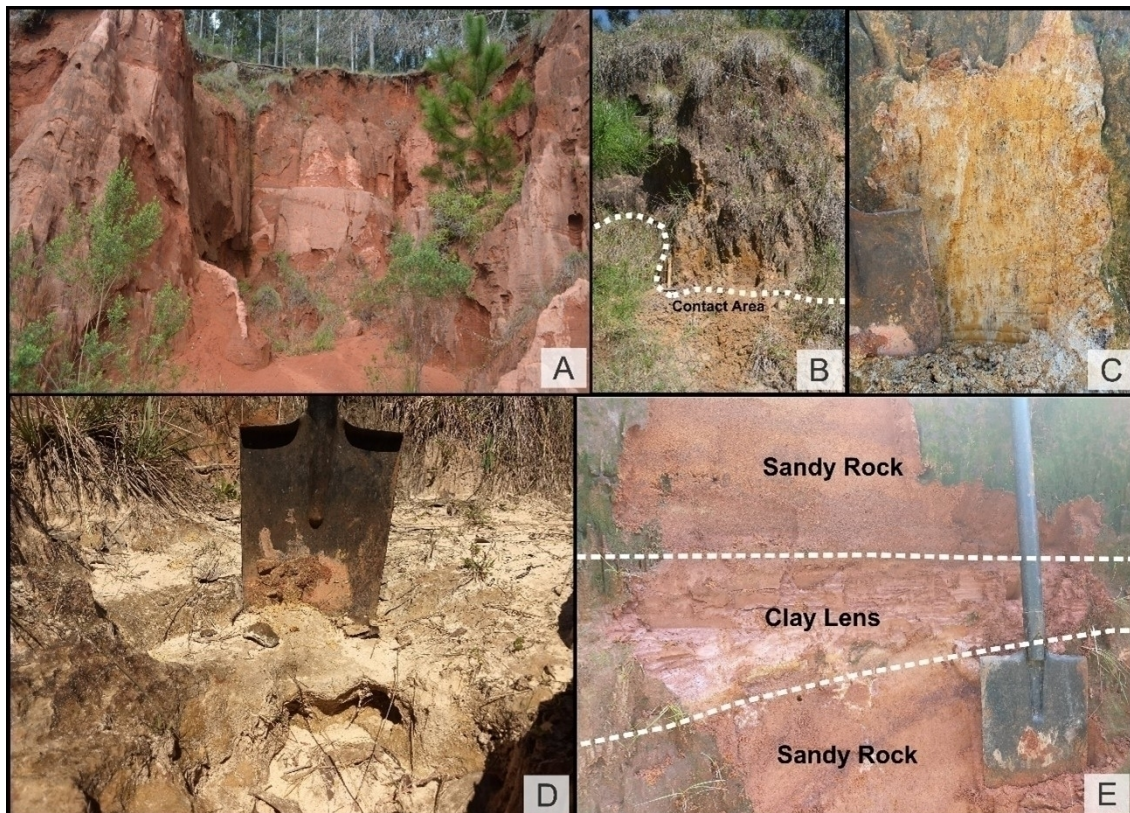
areas, a contact is formed between lithologies with different textures, the sandiest at the top and just below a clayey sheet, as shown in Figure 11 B.

In the contact areas of the sandiest lithology with the clay lenses, the loss of the reddish color of the rock in the sandiest portion (Figure 11, D) results from the leaching of mineral material in the areas of emergence for a long period of time. In the more clayey portion, the identifiable mottled feature (Figure 11, C) is due to the great water availability in this portion.

Figure 11 - A - Occurrence of mass movement in sector B of Areal Gully; B - Contact area of the sandiest rock portion with the most clayey portion; C - Mottled aspect of altered clayey rock blade; D - Sandy portion of the slope with loss of color; E – Alternation of rock lenses with different characteristics in Areal Gully.

understood. In different portions of the gully, lenses of more clayey rock amidst sandy lithology (Figure 11E) form discontinuities and are able to trigger different erosive mechanisms. As noted by Wijdenes et al. (1999) in gullies in southwestern Spain, those with soils containing a textural B horizon were more prone to the occurrence of mass movements and regression alcoves, as also found in Areal Gully. Thus, there is evidence of great interference by lithopedological factors in the erosion mechanisms of the study area, requiring additional studies for further clarification.
