# URBAN WATERSHED MANAGEMENT IN THE BRAZILIAN AMAZON

The Tucunduba Hydrographic Basin (THB) is the second-largest basin in Belém, Pará, draining four densely populated neighborhoods—Marco, Canudos, Terra Firme, and Guamá—with an estimated population of approximately 200,000 inhabitants. This study aims to analyze the socio-environmental conditions of the THB by examining key macro-environmental factors essential to understanding the basin's dynamics. The methodological approach involved conducting 44 interviews with THB residents to assess their socio-environmental perceptions, applying the Simplified Environmental Impact Assessment (SEIA), and estimating per capita sewage discharge across the neighborhoods within the basin. The findings indicate that the Quality of Urban Life Index in the study area is approximately 0.6, reflecting moderate living conditions. The SEIA further revealed substantial environmental impacts, classified as high or very high. These results underscore the inadequacy of public services provided to the local population and highlight the fragility of urban management. Urgent measures are needed to implement an integrated management strategy for the THB, enha

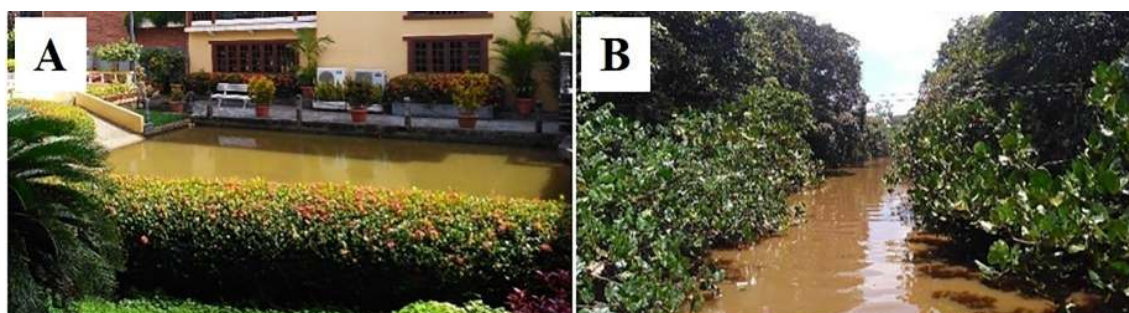
Figure 2 - Sections of the Tucunduba River; A) Source of the Tucunduba river inside private property and B) Mouth of the Tucunduba river. Source: Authors.

The neighborhood of Marco is situated at one of the sources of the Tucunduba River on Lane Angustura, between Avenue Almirante Barroso and Avenue João Paulo II (see Figure 2A). The mouth of the Tucunduba River is located within the territory of the Universidade Federal do Pará, on the right bank of the Guamá River (see Figure 2B).

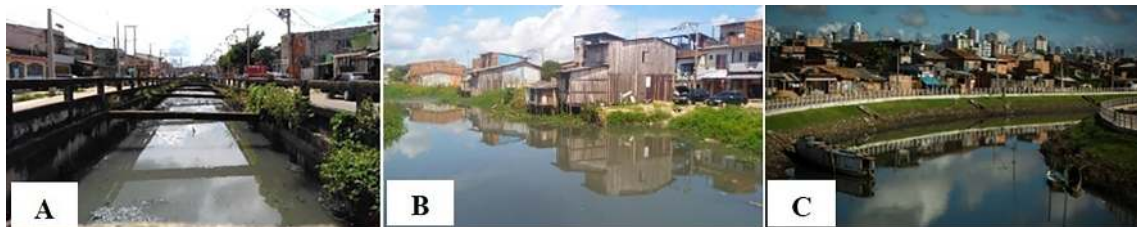
Along the basin, each neighborhood has unique characteristics shaped by urban interventions that modify the landscape and land uses, as illustrated in Figure 3A for the well-known Cipriano Santos Canal in the Canudos neighborhood, Figure 3B for Avenue Celso Malcher in the Terra Firme neighborhood, and Figure 3C for Passagem Tucunduba in the Guamá neighborhood. These figures show the neighborhoods at distinct stages /of development.

Figure 3 - Sections of the Tucunduba River A) Cipriano Santos Canal, Canudos neighborhood. B) Avenue Celso Malcher, Terra Firme neighborhood 2018. C) Passagem Tucunduba, Guamá neighborhood. Source: Authors.

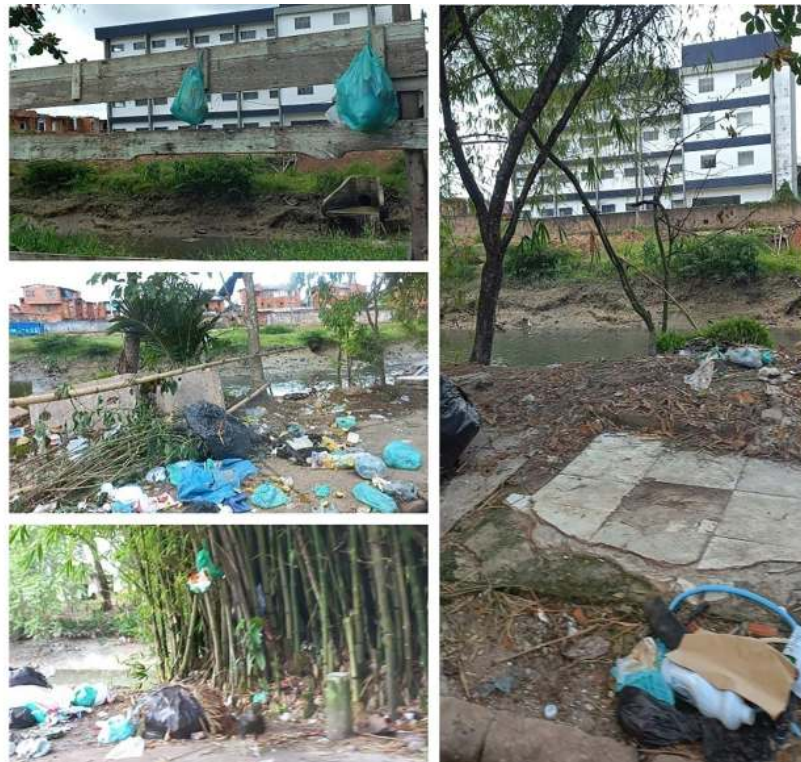
The interviewees reported that, in this scenario, the accumulation of waste in inappropriate places (see Figure 4) could be even more aggravated and could lead to its transport to the watercourse, especially during heavy rains and flooding.

Figure 4 - Photos depicting the disposal of waste on the margins of the Tucunduba River in Section 1 of Stage 1. Source: Authors.

Based on the parameter of solid waste and the excessive presence of materials being discarded in inappropriate places, all sections were found to have a significant amount of dispersed waste. This result confirms the concerns of residents regarding the irregularity of waste collection, which results in dumping on the roads and canal banks.
